Assessment of Potential Archaeological Collections Facility Sites at Edwards Air Force Base

Archaeological Curation-Needs Assessment
Architectural-Archaeological Report No. 1

U.S. Army Corps of Engineers
St. Louis District
Mandatory Center of Expertise for the
Curation and Management of Archaeological Collections

Archaeological Curation-Needs Assessment
Architectural-Archaeological Report No. 1
1998

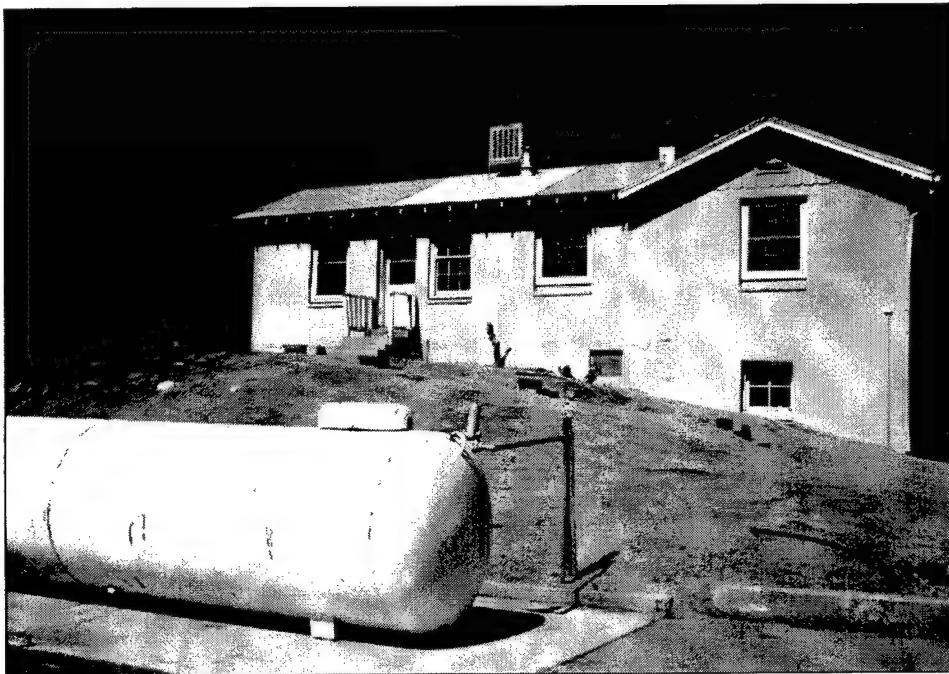
Figure 1. Exterior view of the east side of Building 16. Disabled-persons' access to the first floor will require a ramp.

The exterior walls and foundation are adobe. These show evidence of damage repaired in the past, and numerous cracks are still present throughout the structure. The roof is composition shingle over a wooden deck-and-joist structure. The window frames are wooden and show signs of leakage. The window sills are brick, covered with a cementlike material that is spalling. The first floor of the structure is inaccessible to disabled individuals (see Figure 1).

6. The main floor of the structure should be made accessible to people with disabilities. Currently, access to the first floor requires walking up steps. Site modifications in the form of a ramp or a mechanical lift will be required. To be considered accessible, the interior of the building will require significant modifications, such as enlarged rest rooms, doorways, and hardware.

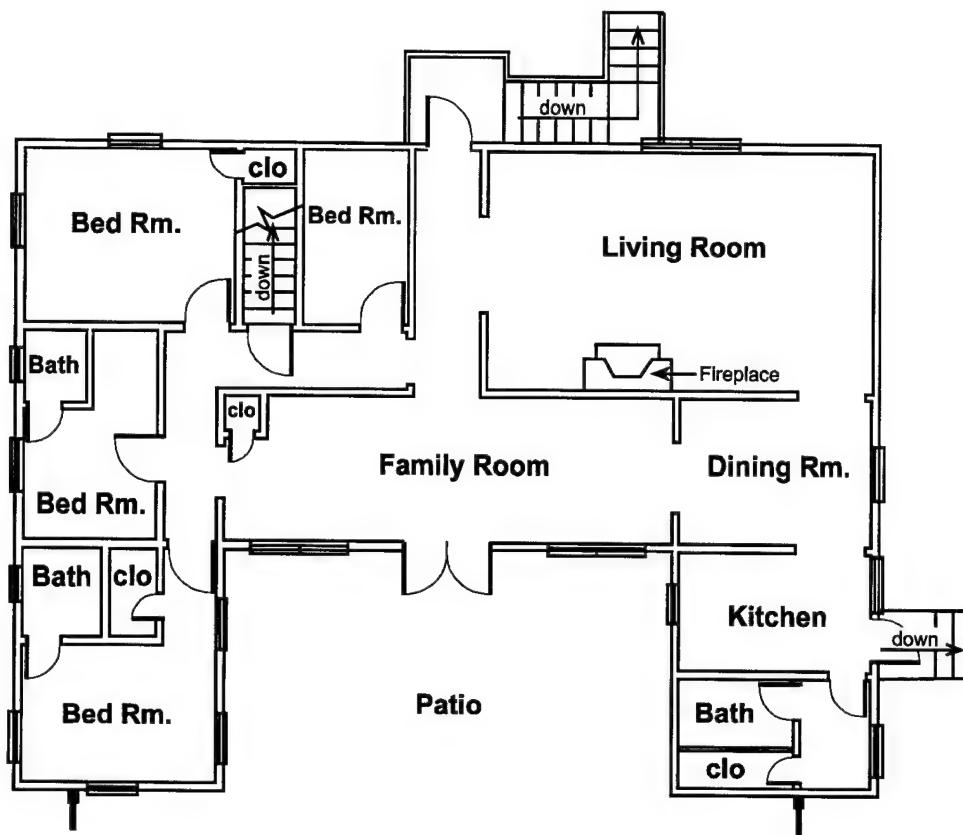
Figure 2. Floor plan (not to scale) of Building 16.
Note the two picture windows in the family room and the one in the living room.

Windows are abundant throughout the house and include several picture windows (see Figure 2). The floors are wood framed; floor coverings include carpet, linoleum, and wood. Interior walls are wood framed, with a plaster and adobe

1. Building 16 was constructed as a residence, with a residential floor-loading design criterion that is typically 40 lbs/ft².
2. It is unlikely that the structure was designed to current seismic-design standards. Existing cracks in the walls may have been caused by earthquakes. Substantial and expensive structural-system additions will be required to reinforce the building and meet minimum standards for storing a lithics collection (250 lbs/ft²).
3. Several large picture windows allow the entry of natural light, which is not conducive to the long-term preservation of archaeological collections. This could be resolved by sealing the window openings with an opaque material, but doing this would seriously compromise the

structure's historic character and be inconsistent with submittal for inclusion in the NRHP.

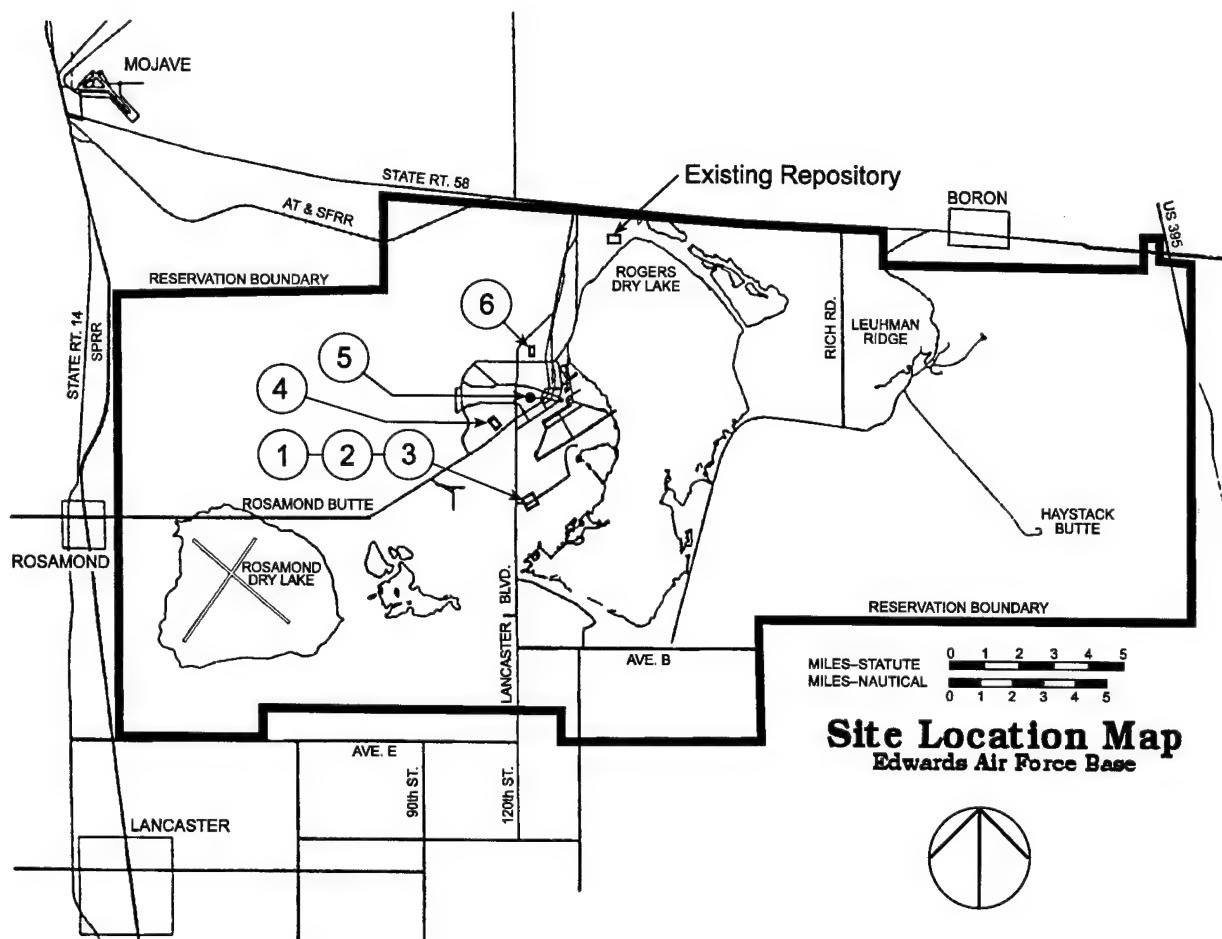
This prominent knoll, which is visible from Lancaster Boulevard, is one of the higher elevations on Edwards AFB. It is located approximately 150 feet southeast of Building 16, making an extension of the access road possible. Despite its favorable location, the base probably will not allow this site to be developed as an archaeological collection facility because of its high visibility.

An archaeological collections facility at this location would benefit from the existing access road and utilities available at Building 16. The site is just downhill from Building 16 and uphill from an adjacent residential subdivision, which has a high traffic flow. The potential for vandalism because of the site's proximity to the residential subdivision, along with the high traffic

flow make this location unsuitable for a collection facility. Furthermore, the potential disposal of chemicals used in the collections facility could pose a threat to the residents of the subdivision.

This site is open and somewhat remote, with very little slope to the ground. It is located at the intersection of the access road that leads to Building 16 and Lancaster Boulevard. Utilities are nearby, and the site is far enough away from the residential area that no adverse reaction from residents is likely. Vehicular traffic generated by the subdivision would pass the site frequently. This site would provide a suitable location for an archaeological collections facility.

Figure 4. Potential sites for a new archaeological collections facility at Edwards AFB.
See text for descriptions of Sites 1-6.

provides a good site for an archaeological collections center, and the cultural nature of the land use is consistent with a future flight test center museum.

These areas are close to utilities, a cafeteria, and other buildings and facilities. A paved road and parking area are also nearby. These sites have advantages over the others visited, including utility connections, vehicle access, and parking. However, this site is not entirely compatible with the cultural nature of the collections facility, because of the other buildings and facilities in the area.

reported to be nearby. Archaeology and biology laboratories used by contractors are housed in temporary structures, and a paved access road serves the site. The proximity to contractors doing cultural resource work at the base is viewed as a desirable characteristic of this site. However, the industrial appearance of the site detracts from its potential use for the location of an archaeological collections facility.
